## Overview of Electrochemical Corrosion at Pipe Supports Causes and Solution

Vijayaraj V T<sup>1</sup>, Omkar Balaji A S<sup>2</sup>, Richin Sanders R<sup>3</sup>, Mohamed Asaruddin A<sup>4</sup>, Prasanna Kumar E R<sup>5</sup>

**Abstract-** *The paper discusses inspection strategy and provides a simplified visual screening method that has proven useful in mechanical integrity programs also the various corrosion mechanisms that occur at pipe supports. Rusting of steel and cast iron in water, including humid air, as occurs with domestic and industrial water tanks and supply piping, automobiles, and exposed steel structures.*

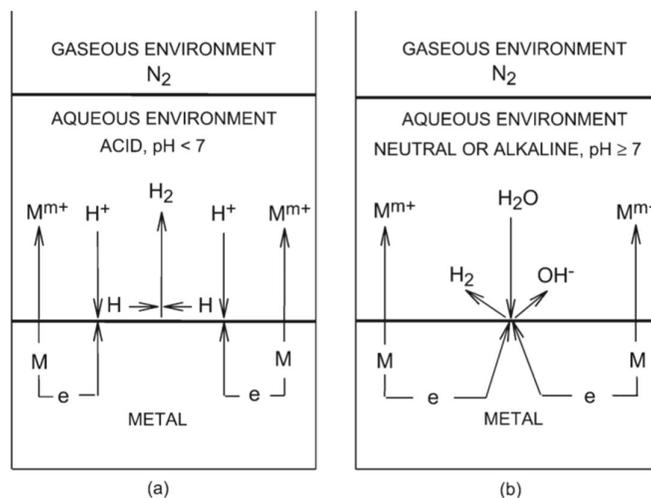
Fig. 1.1 Uniform corrosion supported by controlled pH (oxygen excluded, deaerated). (a) Acid, pH < 7. (b) Neutral or alkaline, pH  $\geq$

Thus, the metal passes from the metallic state to ions of valence  $m$  in solution with the evolution of hydrogen. The reaction is considered to be directly with hydrogen ions in acid solution and progressively with water molecules as the pH increases to neutral and alkaline conditions. Two processes are involved in the reaction, with each involving a change in charge:  $M \rightarrow M^{m+}$  and  $mH^+ \rightarrow m/2 H_2$  (in acid solution). The changes in charge are accomplished by electron transfer from  $M$  to  $H^+$ . Because the metallic phase is an electron conductor, it supports the electron transfer, allowing the two processes to occur at separate sites on the metal surface. In limiting cases, these processes occur within a few atom diameters on the surface with the sites constantly changing with time, thus producing uniform corrosion. Otherwise, the corrosion is non-uniform. Uniform corrosion supported by pH is represented schematically in Fig. 1.1. In this example, oxygen is excluded by a nitrogen gas purge and over blanket.

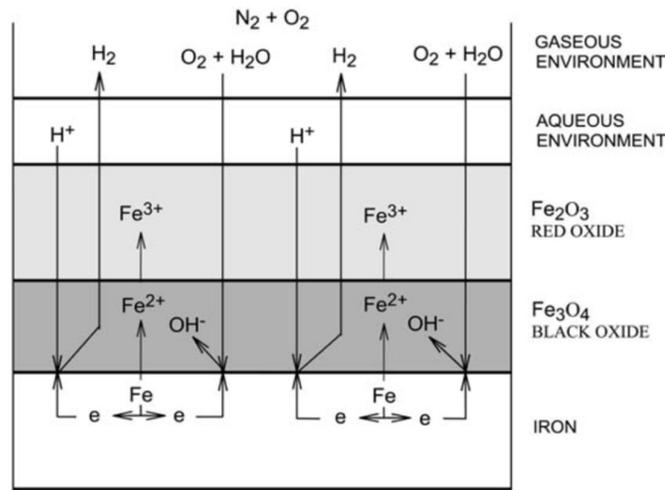
Fig. 1.2 Uniform corrosion with solid corrosion product deposit. Details of the formation of oxide species are not considered at this point.

effective concentration of iron ions ( $a_{\text{Fe}^{2+}}$ ) in the solution, the acidity, or pH, and the concentration of dissolved oxygen that is related to the partial pressure of the oxygen,  $P_{\text{O}_2}$ , in contact with the solution. It is demonstrated in the following chapter that the change in the Gibbs free energy is negative for these reactions at all values of pH, and hence, iron tends to corrode at all pH values. The rate of corrosion, however, depends on factors influencing the kinetic mechanisms of the several processes involved in the transport of ions from metal to solution and in the supporting cathodic reactions. In addition to the species in solution relating directly to the above reactions ( $\text{Fe}^{2+}$ ,  $\text{H}^+$ , and  $\text{O}_2$ ), other species in solution can affect both the tendency to corrode in terms of thermodynamic driving forces and the kinetics of the several steps involved. For example, complexing agents reacting with metal ions in solution reduce the concentration of free metal ions and make it more favorable thermodynamically for metal ions to pass into solution, thereby increasing the corrosion rate. Conversely, if species in solution can form precipitates with metal ions and form protective diffusion barriers at the interface, corrosion rates may be decreased significantly.

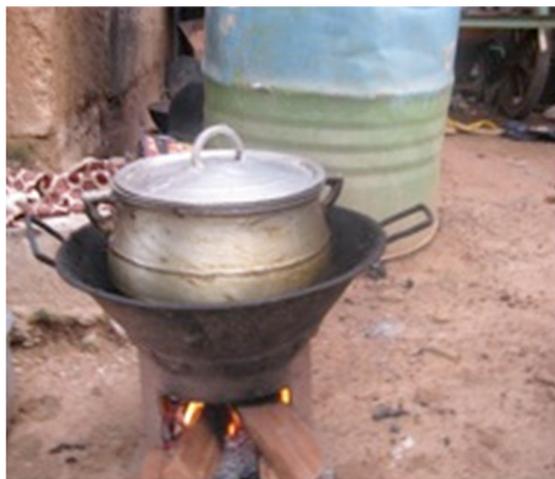
Fig 1.3: Corrosion-susceptible cooking pots from scrap containing aluminium alloys.

A simple example demonstrates the impact of corrosion in everyday life on human health. This example was contributed by Prof. Lucien Bonou from Burkina Faso, Africa, at the WCO workshop during the 17<sup>th</sup> International Corrosion Congress in September 2008. He examined the metal composition of cooking pots produced in his country from recycled aluminium alloys. He found that the material consisted of 32% iron and 10% copper. In addition, considerable amounts of other heavy metals were present (10% zinc, 2.5% lead, and 0.12% cadmium).

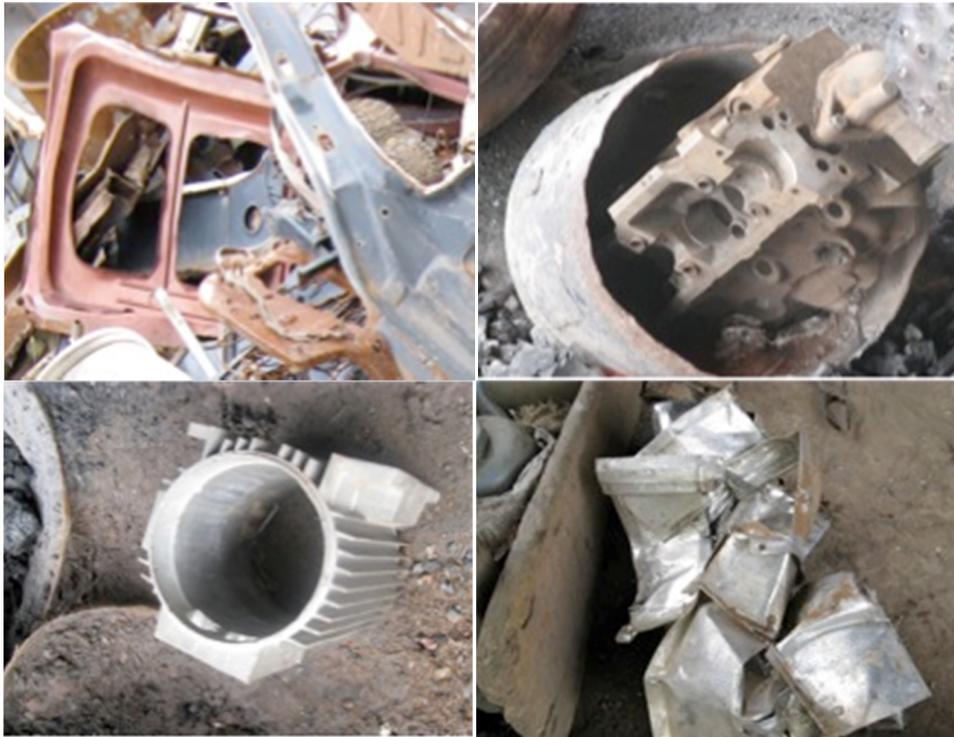
Fig 1.4: Aluminum containing scrap used for cooking pots.

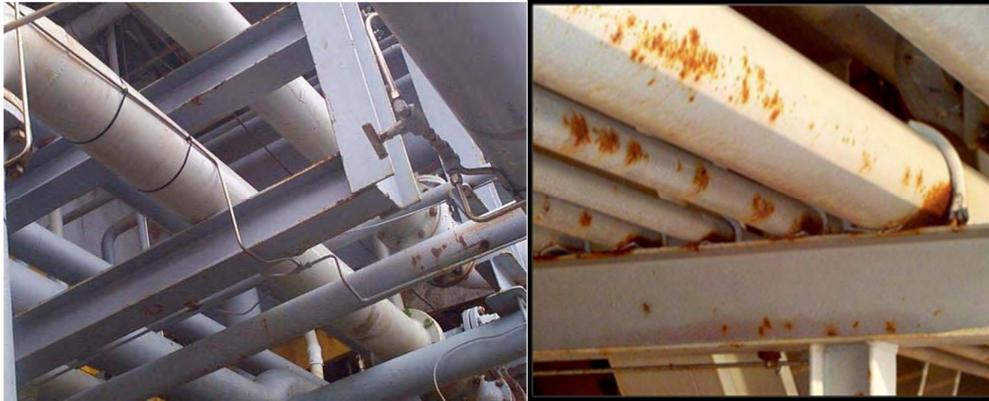
Fig 1.5 U-Bolt Stabilized Beam Supports.

The half round, high strength thermo-plastic rod, meets all of the above requirements. The half round configuration minimizes the crevice at the pipe and allows no water accumulation. The standoff provided allows easy inspection and maintenance at the support.

The metal-to-metal contact is eliminated, and if used with an insulated bolt, the pipe can be totally isolated from the support structure. The low cost material has been selected and configured to optimize compressive strength while exhibiting very low creep, excellent u.v. stability is also a material feature. The material can be deployed as a continuous dressing to the top of a pipe support beam (Fig.1.5), or can be integrated with a stabilizing U-bolt. Either way allows cold work installation for new construction or retrofit applications.

When using U-bolts it is important to apply a polyolefin sleeve over the shank of the bolt. This reduces the risk of cracking the paint film around the pipe as the bolt is torqued down. The olefins provide the right combination of hardness and durability to protect the pipe paint but avoid setting up a capillary crevice around the circumference of the pipe.

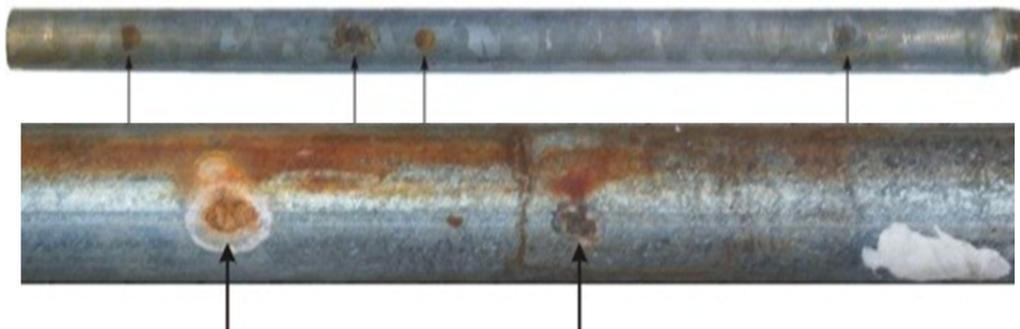
Fig 1.6. Magnified Image of pitting perforation along the weld seam, 5/4" Pipe after 5 years of Service.

The pipe samples which forms a part of two hot water distribution systems exposed approximately: first one for 2 years (region I) and second one for 5 years (region II) to flow water delivered by two public supplied sources in the city has been considered for the study. After this short service life galvanized pipes experiencing pitting failures, as it shown in Figure 1 (after 2 years of service) and Figure 2 (after 5 years of service).

The premature corrosion failure of zinc-coated steel pipes in both examined hot water distribution systems was due to the loss of the internal protective zinc layer as most probably the result of inadequate water chemistry, which will be discussed later. An example of the break in zinc coating on the inner pipe surface which promotes further pit initiation and growth is presented in figure.
